ALL IN HOME INSPECTIONS LLC

1234 Main Street Pinedale, AZ 85934

> Buyer Name 04/05/2024 9:00AM

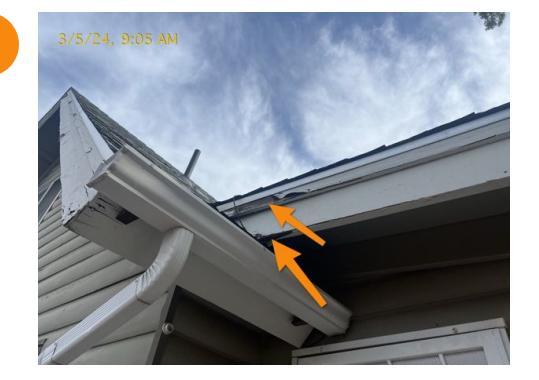
2.2.1 Flashing and Trim

TRIM DECAYED

NORTH EXTERIOR

I observed wood trim decayed in one or multiple areas of the exterior. Recommend repairs as needed.

Recommendation Contact a qualified siding specialist.

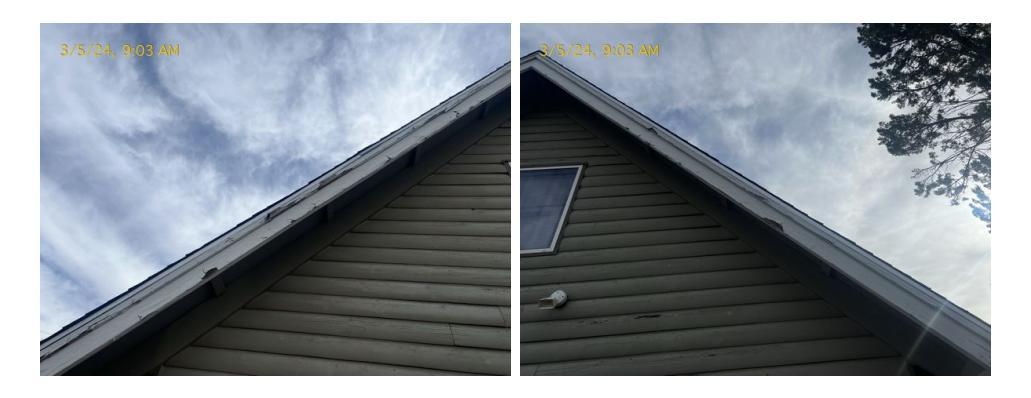
2.3.1 Eaves, Soffits, & Fascia

FADED PAINT

EAST EXTERIOR

I observed one or multiple area of faded or flaking paint on the eaves, soffits, or fascia. Recommend repairs as needed to prevent deterioration.

Recommendation

Contact a handyman or DIY project

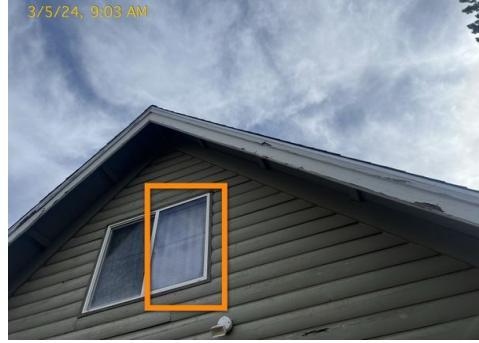
2.5.1 Windows FAILED SEAL- STAINS

NORTH EXTERIOR

Although no condensation was visible at the time of the inspection, staining of the glass at a window indicated a loss of thermal integrity. Windows with failed seals can only be seen at certain times of the day. The Inspector recommends that before the expiration of your Inspection Objection Deadline you consult with a qualified contractor to discuss options and costs for repair or replacement. Replacement is more common.

Recommendation

Contact a qualified window repair/installation contractor.

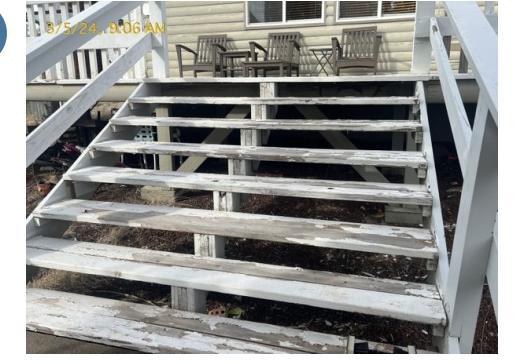
2.6.1 Steps and Railings

MISSING PAINT DECK STAIRS

l observed paint missing in one or more areas, recommend painting to prevent deterioration.

Recommendation

Contact a qualified professional.

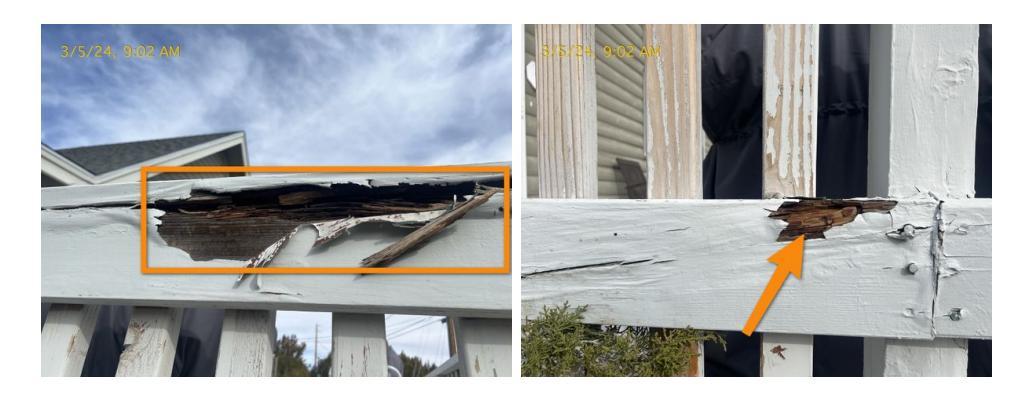
2.6.2 Steps and Railings

SIGNS OF WOOD DECAY

I observed railings that showed signs of wood decay. Recommend correction by a contractor to prevent further deterioration.

Recommendation

Contact a qualified professional.

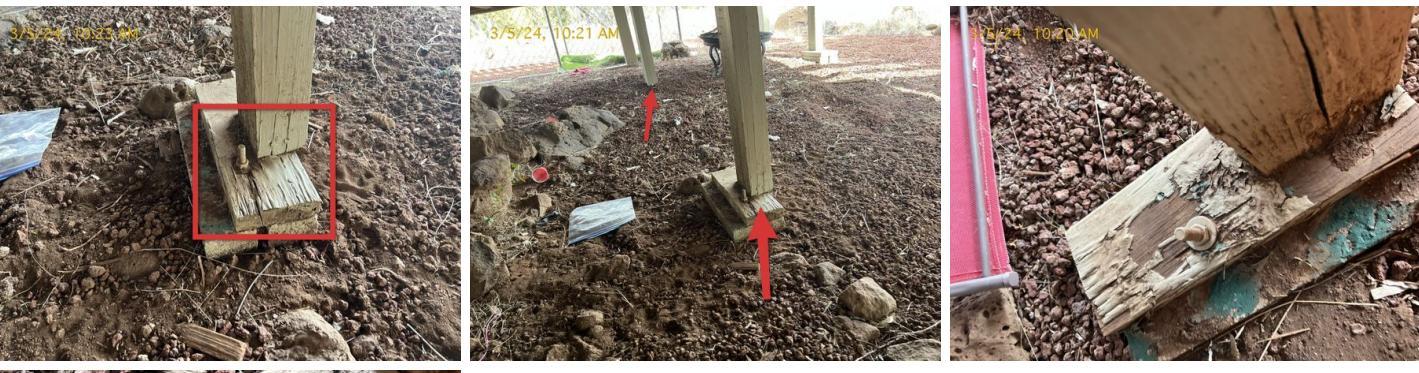
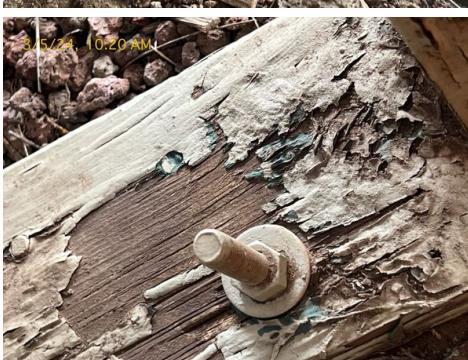
2.7.1 Deck/Balcony

DECK WITH MULTIPLE SAFETY ISSUES/POOR CONSTRUCTION DECK

Multiple defects were observed on the deck, cover, steps and railing including, but not limited to:

- Wood decay on joists, stair stringers, and support members.
- Loose railings
- Signs of possible pest intrusion
- Tripping hazards
- Unequal tread rise
- -Loose pillar capstones

The add up to cause a safety concern. Recommend further evaluation and repairs by a qualified person.

Deck structural framing had advanced wood decay visible at the time of the inspection. Advanced wood decay can seriously weaken any affected members making the deck unsafe.

Recommendation

Contact a qualified deck contractor.

You should consult with a qualified contractor before the expiration of your Inspection Objection Deadline to discuss options and costs for correction and any necessary repairs or replacement.

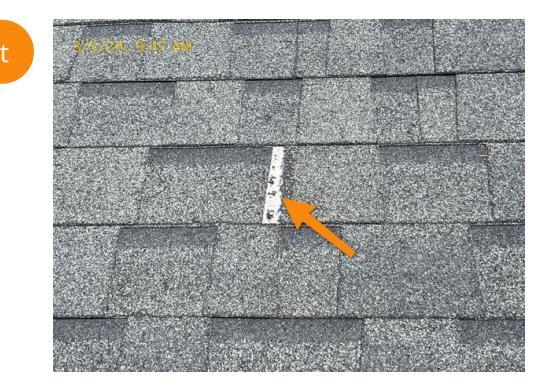
3.1.1 Roof Covering

GRANULE LOSS

ROOF

I observed granule loss at the asphalt shingle roof. Granule help shed water off the roof. Lack of granules typically means the roof is aged. Recommend further evaluation by a roofing contractor.

Recommendation

Contact a qualified professional.

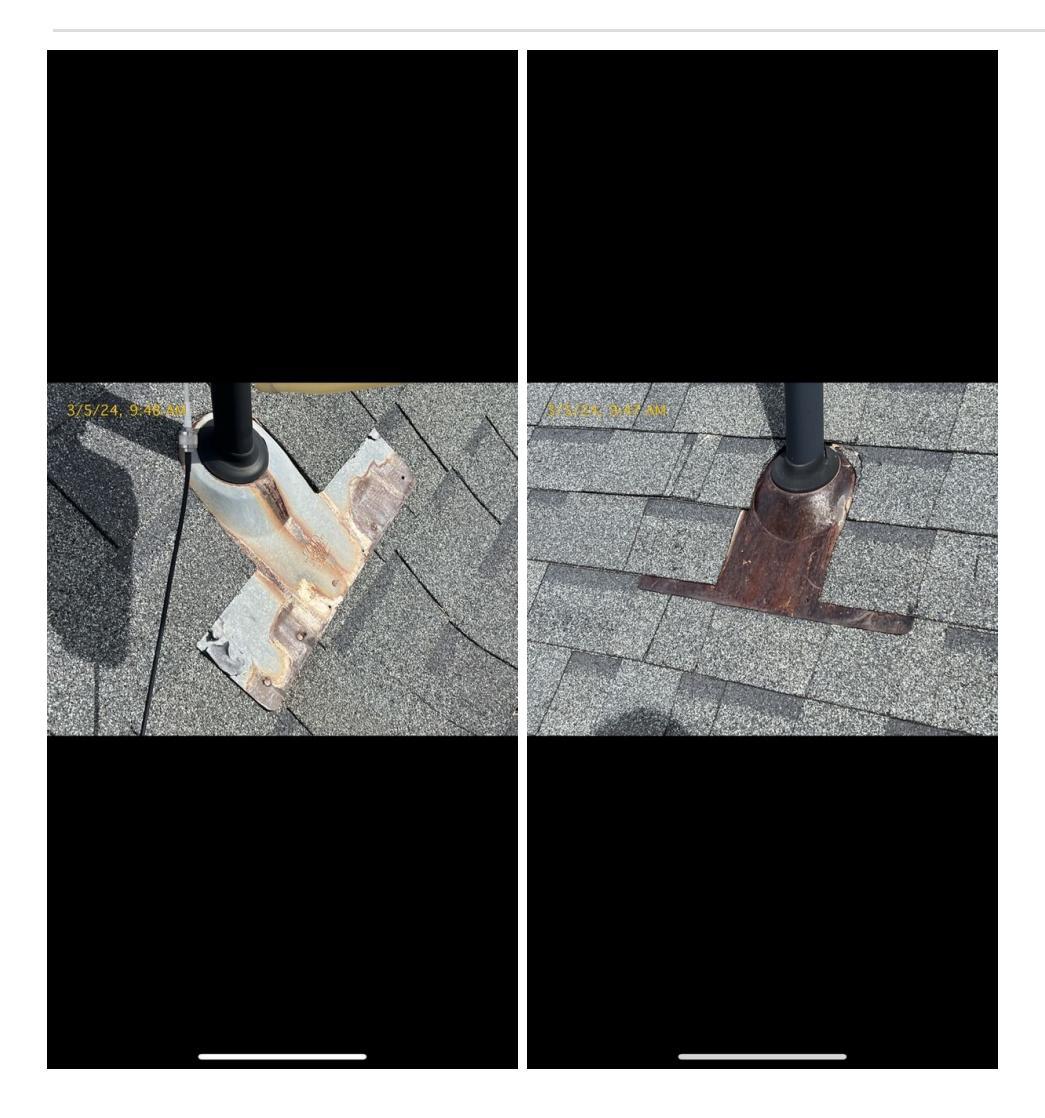
3.2.1 Flashings and Penetrations

MODERATE CORROSION

ROOF

Roof flashings were generally old and showed general moderate corrosion throughout the roof. Flashings should be monitored annually and replaced before they begin to leak.

Recommendation Recommend monitoring.

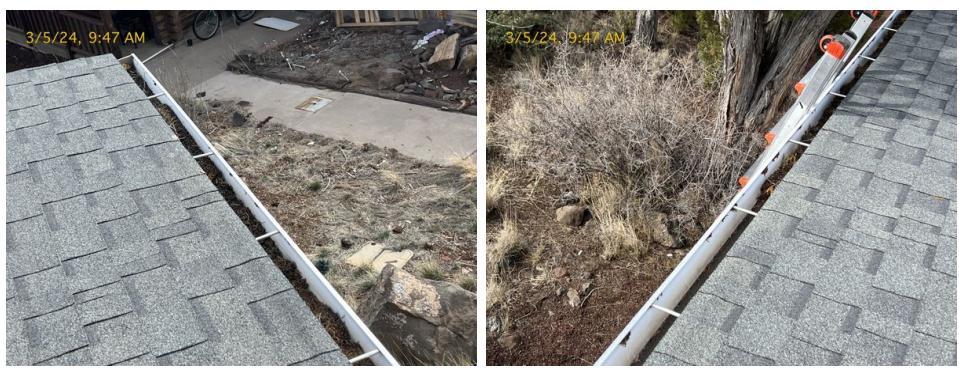
3.3.1 Drainage Systems

DEBRIS

GUTTERS

Debris visible in the gutters at the time of the inspection should be removed to encourage proper drainage.

Recommendation

Contact a qualified professional.

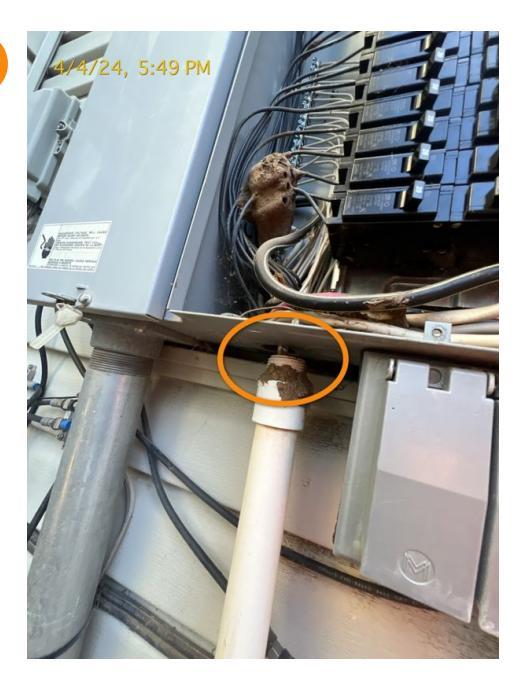
5.2.1 Main Panel/Distribution Panels

CONDUIT SEPERATED

MAIN PANEL

I observed conduit that was disconnected and separated from the main panel. This can be a way of entry for pests and moisture intrusion. This could explain why there are wasp nests in the panel. Recommend repairing as needed.

Recommendation

Contact a qualified professional.

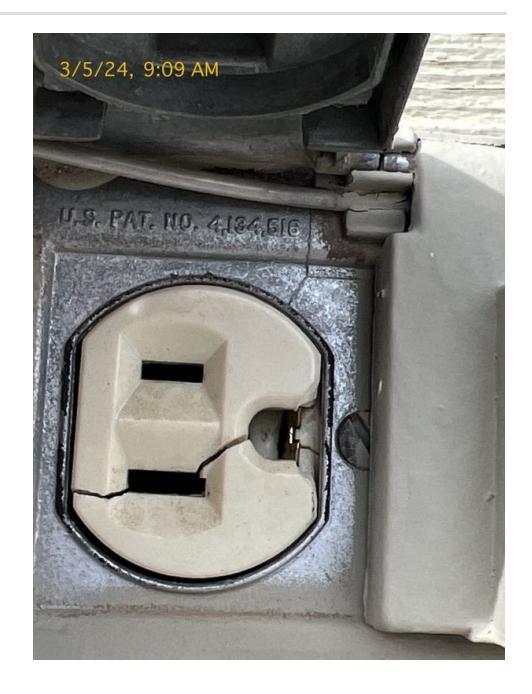
5.8.1 Receptacles, Polarity, Ground

RECEPTACLE DAMAGED

DECK RECEPTACLE

The home had a damaged electrical receptacle that should be replaced by a qualified electrical contractor.

Recommendation

Contact a qualified electrical contractor.

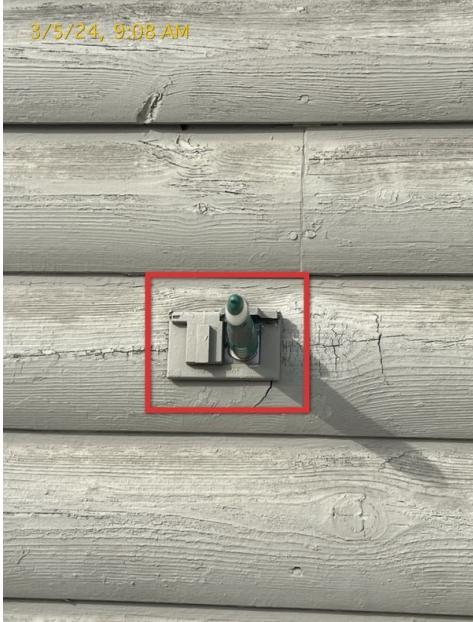
5.9.1 GFCIs

GFCI MISSING

DECK RECEPTACLE

I observed one or more receptacles without GFCI protection in areas where needed. GFCI protection is required in bathrooms, kitchens, garages, exterior, or any outlet within 6 feet of a water source. Recommend installing GFCI protection for safety.

Recommendation

Contact a qualified electrical contractor.

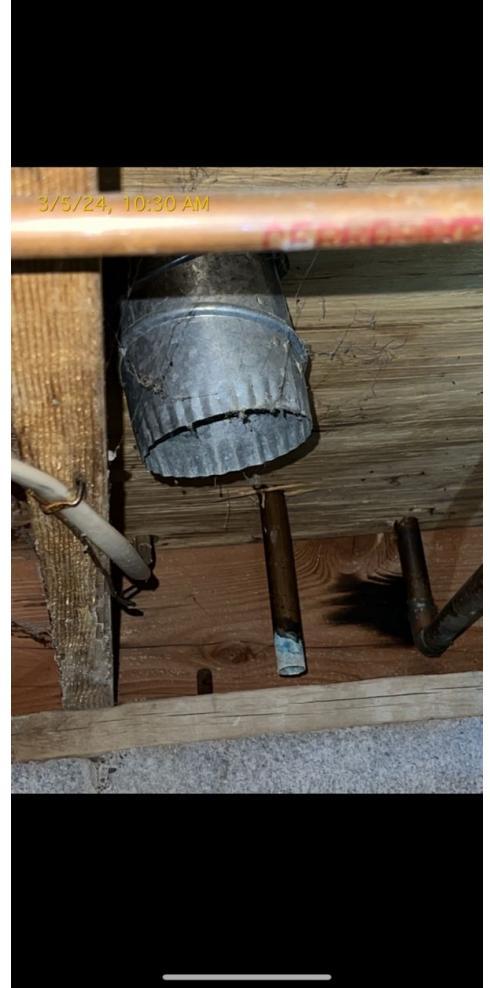
I observed the dryer vent terminating in the crawlspace. This can cause dust to build up in the crawlspace. Recommend terminating it to the exterior.

Recommendation

Contact a handyman or DIY project

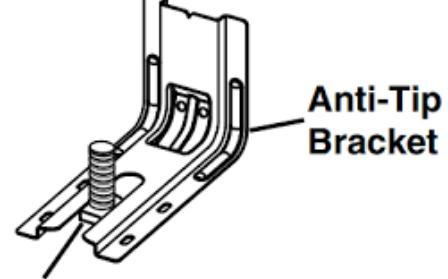
Range Foot

MISSING ANTI-TIP BRACKET

I observed a missing anti-tip bracket at the range. This a potential safety hazard due to children potentially climbing and tipping the range causing injuries and/or death. Recommend installing a anti-tip bracket as necessary.

Recommendation Contact a handyman or DIY project
